Forced Performance 2004-2007 Subaru 2.5l Bulletin 12/1/07, UPDATE 9/1/08

Oil Starvation of Turbos on Subaru Vehicles: Why and How.

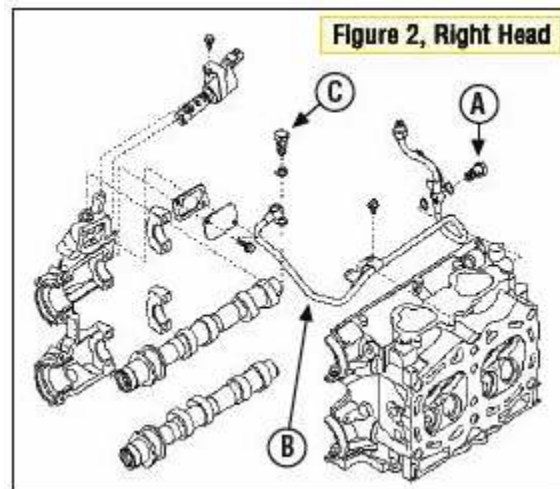
Turns out that there is an oil filter screen built into the factory oil feed banjo bolt at the cylinder head, and Subaru wants it removed completely in order to avoid turbocharger oil starvation and failure. The Subaru Service Technicians (from dealerships) we interviewed on this subject reported recurring turbocharger failures even on completely stock 2.5 WRX, STi, Forrester and Baja vehicles due to this problem, prompting an Official Subaru Service Bulletin in October 2007. Material collected in these screens consisted of mainly gummy sludge and carbon with flakes of metal from various internal engine components. In one reported case in Alabama, even a low mileage 05 Baja which had all its regular 3k mile oil changes at the dealership experienced a stock turbocharger failure due to this oil filter becoming plugged with sludge.

The turbocharger filter can be seen in the diagram below, it is marked "A"

"the mesh screen which is located inside the banjo bolt that secures the turbocharger oil supply pipe to the back of the right side cylinder head should be checked to make sure it is not clogged or restricted especially if the condition of the oil is questionable or as to when the last oil change was performed. If clogged or restricted, it will reduce or cut off the oil supply to the turbo resulting in failure. The oil supply pipe should also be checked to make sure that there are no obstructions."

Forced Performance recommends REMOVING this "Turbocharger Oil Supply Mesh Screen" in all vehicles running our FPGreen and Red model turbochargers. The thrust bearing used in these turbochargers has very little tolerance for reduced or limited oil supply. In fact this bearing actually requires approximately TWICE the oil volume as a stock IHI turbocharger and can die a quick and sure death if fed its life giving oil through one of these restricted filters. It is also completely possible that a slightly restricted filter will

To clarify – REMOVE THE FILTER SCREEN FROM ALL BANJO BOLTS.
