SERVICE BULLETIN

APPLICABILITY: All Vehicles Equipped with Turbo
SUBJECT: Turbocharger Mesh Filter Screen

NUMBER: 02-106-08
DATE: 08/26/08

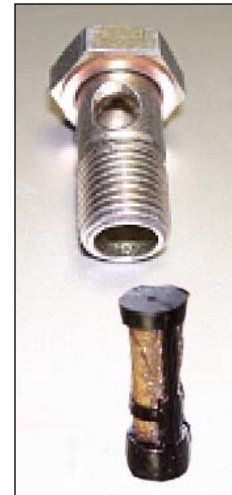
It is possible that the turbo oil supply mesh filter, which is located inside the banjo bolt that secures the turbocharger oil supply pipe to the back of the right side cylinder head, may become clogged thereby preventing oil supply to the turbo resulting in failure. Therefore it is required that this filter screen be checked for obstructions any time a Turbocharger is being replaced for a failure.

- **Note:** The mesh filter screen is only available with a replacement banjo bolt. (P/N 14445AA090) Tightening torque: 29 N•m (3.0 kgf-m 21.4 ft-lb).
- **Note:** Anytime the banjo bolt is removed or replaced, both copper washers must be replaced with new ones.
- Make sure the mesh filter screen is installed in the proper direction; incorrect installation will prevent oil supply to the turbocharger. (Note direction, in picture to the right).
- **Do not confuse** the turbocharger oil supply mesh filter screen with the Active Valve Control System (AVCS) union screw mesh filter screen. Refer to Service Bulletin 02-97-05, dated 10/06/05.

If the mesh filter screen is found to be obstructed it should be cleaned or replaced. Obstructions could be sludge due to poor engine oil maintenance or harsh driving conditions. Further diagnosis may be required if significant amounts of sludge, metal, and/or other materials are found in the mesh filter screen. In any turbocharger replacement, sufficient oil pressure to the turbocharger should be verified. Please consult the service manual for the appropriate specification.
